Career Episode 1

Case Study & Analysis of AutoDelfia Abnormal Results

Title: Case study about the abnormality of result values of AutoDelfia (automatic immunoassay system) in Cheil General Hospital & Women's Healthcare Center

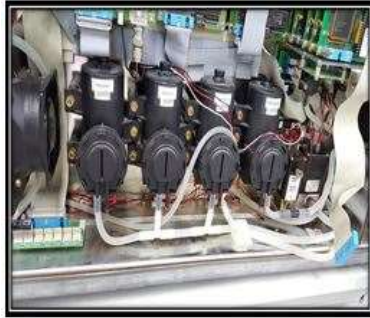
Fig. Second-generation pump set

The reason why 2nd-generation pumps are upgraded to the 3rd-generation pumps is because condensed water is generated and it flows backward the pumps, thus shortening the longevity of the pumps. Performance of one of the three vacuum pumps is weakened, which noticeably reduces the longevity of the other two pumps. In order to prevent these problems, tubing is curved before it is installed, but there are reports that water still flows into the pump because the location of tubing is changed due to vibrations made when a suddenly high pressure is applied to the tubing because the tubing is not fixed securely. So, I developed the third-generation pump set and supplied. Overall, I noted the improvement in the performance, and the curved tubing for preventing water from flowing backward was fixed securely on the rear side of pumps so the problem of changing positions of tubing due to vibration was solved. Because the cable connected to the connection board and the power supply was changed, I installed an upgraded connection board (upgraded connection board was pointed by a finger in the figure of 3rd generation pump).

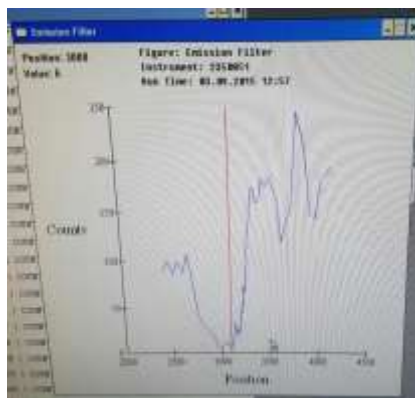
Fig. Result of the Emission Filter changer Test

In the process of the biannual preventive maintenance, I additionally examined the position of an emission filter and obtained a result as below. Ideally, only one highest peak value should be produced and in the part of a light shutter, i.e., the part with no filter, the light should be blocked and counted as near zero. With the result below, I decided that there is a problem with light leaking or an emission filter changer itself has problems. So, I held a video conference twice with the engineers of the manufacturer of the equipment to find out what kind of additional inspection should be carried out. They suggested that I should replace the entire measuring unit, but there were a number of problems about that: the measuring unit is expensive; the customer has to wait for a long time because currently there was no stock left, and our sales team and my colleague engineers in our company gave me their opinions that it was not viable given the break-even point of the measuring unit. Therefore, I decided to perform the re-calibration of discriminator levels and carry out the inspection of the emission filter set for repairing the measuring unit itself.

After I finished the set up in the discriminator, I was able to find the position where a count value is almost zero at the step/stage of defining an oscillation level. And this means there was almost no light leaking. In other words, it looked like the possibility of leaking goes higher when the positions of filters were changed. The emission filter has four positions in it in total, and it comprised the parts of Sm (642nm), Tb (545nm), Eu (616nm), and Light Shutter (a blocked part with no filter). And it was connected to a step motor so that the position of a filter can be adjusted to the type of a label. When I performed the position calibration of the emission filter repeatedly, I found out that the resultant graph forms of counts were not consistent and that the step motor was unusually overheated after it began to operate. I could assume that the antiquation of the step motor itself or the abnormality of an LCC board that controls the step motor has caused the malfunction. I could also presume that intermittent malfunctions of the step motor prohibited a light shutter from being perfectly closed and thus may cause the production of untrustworthy random result values. Though the price of a step motor was inexpensive, if I replace it with a new one when the operation of the LCC is still in error, the new step motor will be adversely affected by it. Also, it is difficult to allocate more time to the troubleshooting because currently, the customer has many overdue samples of patients that need to be examined. Therefore, I decided to replace both the LCC control board and the step motor at the same time. After securing a backup of the parameters of this LCC board, I installed a new LCC board and then entered the parameters.

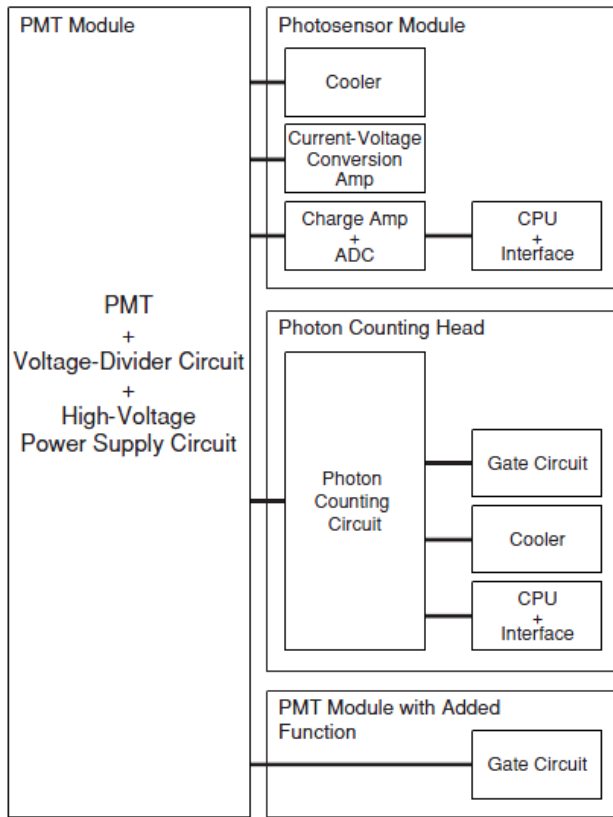
Fig. PMT with High-Voltage Power Supply Circuit

[CE 1.12] By discriminator level, it meant a level of no noise and it was set up to improve an SNR (signal-to-noise ratio) and prevented the drift of data. An oscillating circuit was used in the high-voltage power supply circuit which was connected to the PMT that acts as a detector, and here unwanted noises are generated from an output terminal which was called a ripple. If a threshold of the discriminator was established higher, a rate by which a little change in an input terminal influences results values also rises. Therefore, I worked on establishing the threshold which was being higher than noise and lower than a signal. For this equipment, an oscillation level should first be found. Then the oscillation level plus 10mV was established as the discriminator level. After finishing this setup, I established the filter position of the measuring unit and flash rate calibration of a light source and other works were performed.
