## CAREER EPISODE 1

### **Construction of New Muscat and Salalah International Airport**

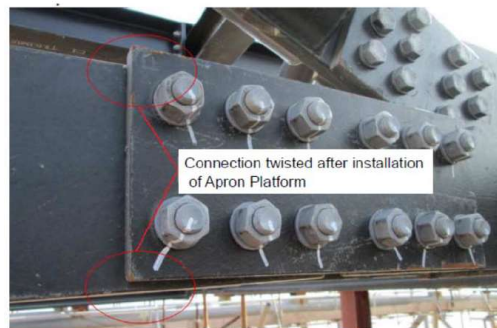
- CE 1.16 During the site inspection in the departure area at the terminal building I noticed excessive deflection of the roof structure, specifically the secondary steel trusses holding the roof system and transferring the loads to the main space trusses. I investigated if the correct methodology was followed for the installation. I also inspected the connections, and noticed excessive rotation in the connections – I took photographic evidence.

CE 1.19 From the investigation I found that in there is underestimation of the connection stiffness. This underestimation contributed to a large deformation of the structure under the imposed loads during the construction.

CE 1.20 I organized a meeting with the structural coordinator and lead structural engineer to explain my observation and during the meeting where they verified my findings. I proposed to proceed with the additional welding around the connection to avoid refabricating and complete redesign.

CE 1.21 Since the structure was already deflected, I discussed several options with the contractor and we agreed to proceed with propping and reducing the loads with temporary structure that would take the self-weight loads. I instructed the contractor to submit this methodology for approval from the client.

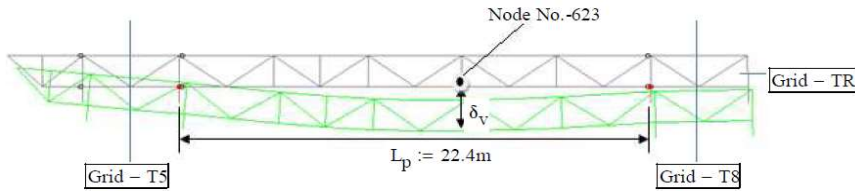
- CE 1.17 I informed my line manager and raised NCR on Aconex (document management system) describing the non-conformance along with the project specification and standard references.
- CE 1.18 I investigated the shop drawings showing the connection details and calculation reports for these connections to recheck the verification. I also evaluated the structural model and the analysis report to understand the behaviour under construction.

Sl. No.	Loading Condition	Deflection at below marked node (mm)
1	Self weight without Roof Sheeting, Oval Duct and ACR including Live load	46
2	Self weight, Roof Sheeting and Oval Duct including Roof Live Load without ACR	100
3	Self weight, Roof Sheeting, Oval Duct, ACR including Roof Live Load	106
4	Under complete loading at final design condition	180

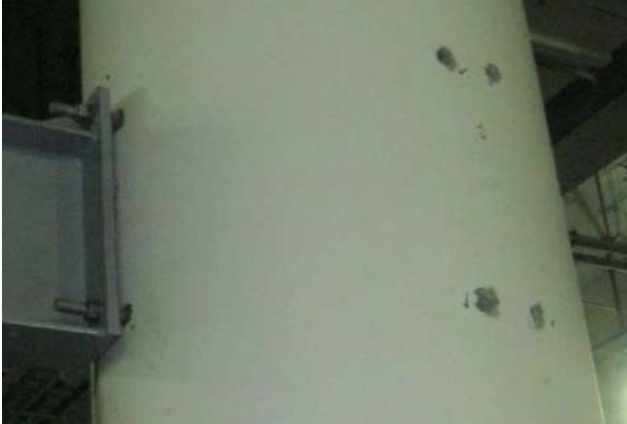
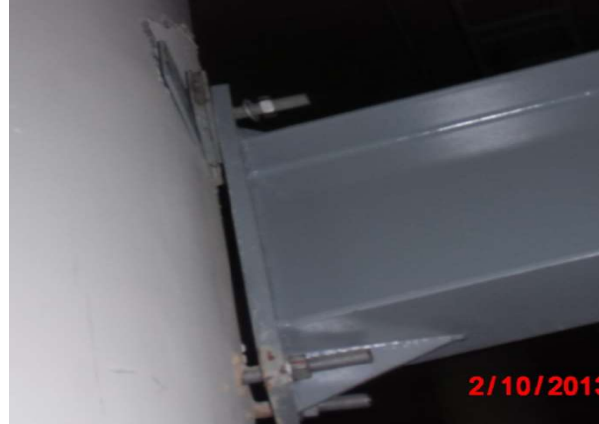
CE 1.23 During the site visit with the client around the passenger terminal building, I observed in the baggage handling area that the MC8 contractor had started the installation of the steel beams of the mezzanine floors. I observed numerous

deficiencies in the installation methodology practices, and discrepancies in installing the steel beams around the columns.

- CE 1.25 I organized a meeting the responsible RE, draft the letter identifying all the non-conformances and advised him to send the letter to the contractor. The contractor also conducted a study with his design engineers to assess these observations.

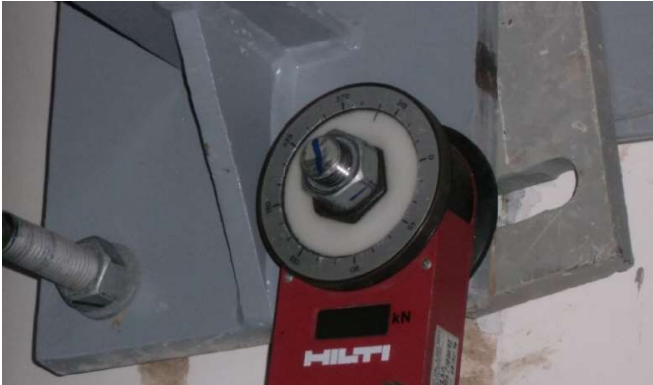
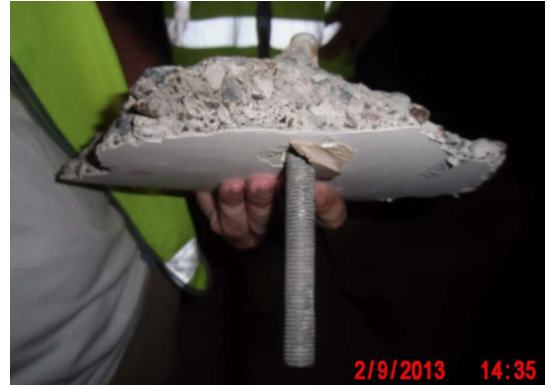
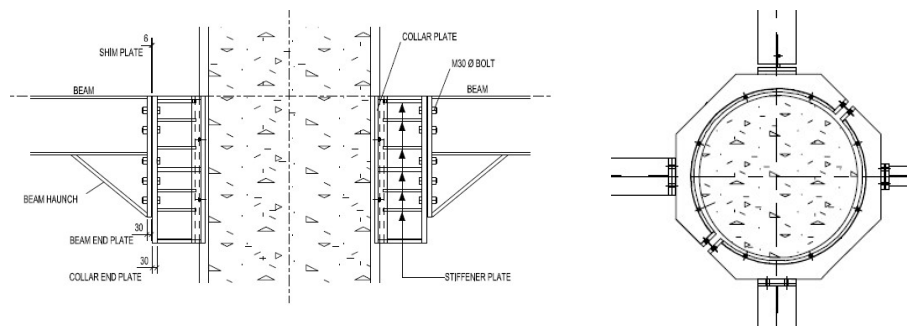
- CE 1.28 I organized several workshops with the contractor's designer to put an action plan and resolving these issues. I instructed the contractor to organize random pull test to determine adequacy of the anchors. During the pullout test I observed a major failure in the concrete cone.

CE 1.29 After the assessment of the pull-out failure, I called urgent meeting with the main designer and gave a possible solution to provide clamp connections “collar” around the columns to have the complete moment restraint and better support conditions and reduced drilling on the heavily reinforced columns. After agreement I proceeded. The revised analysis calculation report for the structure verified the support conditions and related loadings as per UBC 1997 I thus approved the calculations of the structure.

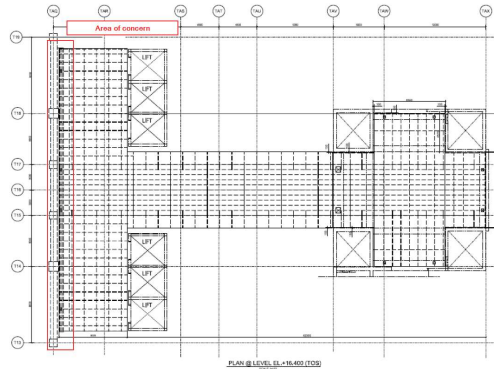
CE 1.33 After installation of the bridge and the lift shafts, I found that the hall the end of the bridge had disproportionate slope at the corner of the bridge. I asked the contractor representative to check with the survey report for actual deflection and evaluate the results. In the concerned portion of the bridge the results were showing deflection of around 10mm. My string line check showed much a higher deflection of approximately 18 mm from the one printed in the geometrical survey report.

CE 1.38 After the loading was completed and the result found to comply with the initial analysis, it was agreed to rectify the excessive deflection area with local modification on the upper part of the plate elements and the level difference to be rectified with levelling screed.
