CAREER EPISODE 2

Time duration	December 28, 2017 to Jan 2, 2018
Location	Saudi Arabia
Organization	General Electric (www.gepower.com)
Project	High Vibration on Air Cooled GE 7A6 Generator
Position	Senior Manager (Site Manager)

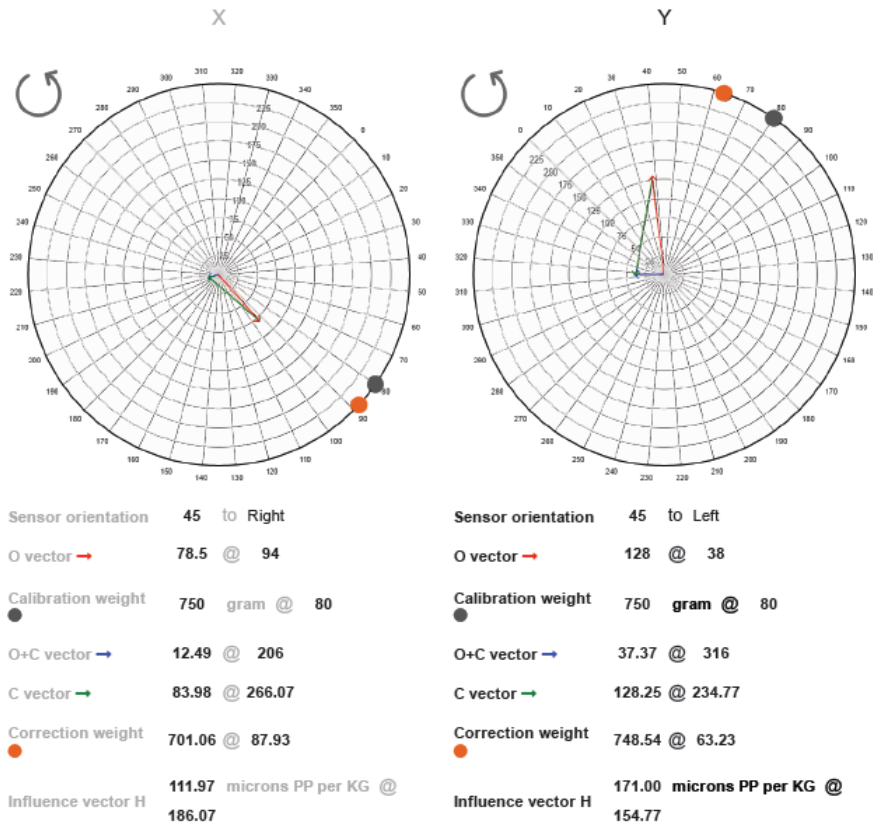
GEN COLLECTOR END

GTG#2 Generator Balancing							
Initial Run							
	91X	92Y	8810	8811	101X	102Y	8812
Direct	55.39 microns pp	74.50 microns pp	18.41 mm/s pk	18.12 mm/s pk	78.49 microns pp	132.24 microns pp	19.18 mm/s pk
1X	39.41 microns pp	50.20 microns pp	18.07 mm/s pk	17.71 mm/s pk	66.38 microns pp	127.13 microns pp	18.33 mm/s pk
Phase in Degrees	268	203	290	287	94	38	287
Calibration weight of 450 grams installed at 220 degrees on collector end balance plane							
Direct	65.53 microns pp	90.38 microns pp	22.18 mm/s pk	22.86 mm/s pk	95.10 microns pp	136.32 microns pp	24.95 mm/s pk
1X	49.41 microns pp	75.61 microns pp	21.67 mm/s pk	22.52mm/s pk	79.47 microns pp	131.62 microns pp	23.53 mm/s pk
Phase in Degrees	259	186	277	280	79	25	269
Correction weight of 1050 grams installed at 110 degrees on collector end balance plane							
Direct	37.24 microns pp	69.91 microns pp	11.85 mm/s pk	12.33 mm/s pk	32.22 microns pp	75.45 microns pp	8.02 mm/s pk

1X	28.95 microns pp	65.33 microns pp	11.12 mm/s pk	11.66 mm/s pk	14.25 microns pp	65.55 microns pp	7.18 mm/s pk
Phase in Degrees	178	79	221	226	19	341	194
After relocation of the weights of 1050grams at 85 degrees on collector end and data was taken after 12 hours of base load							
Direct	44.26 microns pp	62.5 microns pp	9.97 mm/s pk	10.25 mm/s pk	24.67 microns pp	47.42 microns pp	4.85 mm/s pk
1X	27.7 microns pp	56.3 microns p	9.38 mm/s pk	9.65 mm/s pk	12.49 microns pp	37.37 microns pp	4.17 mm/s pk
Phase in Degrees	150	58	162	164	206	316	124
After relocation of the weights to 750 grams at 80 degrees on collector end and data was taken at FSNL							
Direct	29.03 microns pp	41 microns pp	8.5 mm/s pk	8.8 mm/s pk	29.27 microns pp	60.2 microns pp	1.94 mm/s pk
1X	19.03 microns pp	32.48 microns pp	7.76 mm/s pk	7.98 mm/s pk	10.75 microns pp	47.67 microns pp	1.18 mm/s pk
Phase in Degrees	170	66	180	182	101	346	198

After relocation of the weights to 750 grams at 80 degrees on collector end and data was taken at baseload							
Direct	32.12	47.9	8.05	8.28	23.73	55.9	1.85

microns pp	microns pp	mm/s pk	mm/s pk	microns pp	microns pp	mm/s pk
1X	17.66 microns pp	36.32 microns pp	7.35 mm/s pk	7.63mm/s pk	9.79 microns pp	40.91 microns pp	1.15 mm/s pk
Phase in Degrees	165	60	181	184	139	340	132
After relocation of the weights to 750 grams at 80 degrees on collector end and data was taken after 1 hour of baseload							
Direct	36.69 microns pp	54.8 microns pp	8.68 mm/s pk	8.74 mm/s pk	24.76 microns pp	53.1 microns pp	3.10 mm/s pk
1X	18.30 microns pp	39.8 microns pp	7.89 mm/s pk	8.18 mm/s pk	11.05 microns pp	36.58 microns pp	2.42 mm/s pk
Phase in Degrees	153	52	164	167	163	327	103
After relocation of the weights to 750 grams at 80 degrees on collector end and data was taken after 15 hours at baseload							
Direct	42.40 microns pp	59.5 microns pp	8.91 mm/s pk	9.16 mm/s pk	21.98 microns pp	51.3 microns pp	3.74 mm/s pk
1X	22.35 microns pp	42.13 microns pp	8.26 mm/s pk	8.53 mm/s pk	9.13 microns pp	39.99 microns pp	3 mm/s pk

Phase in Degrees	150	47	165	167	166	323	105
After relocation of the weights to 600 grams at 65-70 degrees on collector end and data was taken after 24 hours at baseload							
Direct	40 micron	60 micron	7.98 mm/sec	8.14 mm/sec	30 micron	50 micron	2.23 mm/sec

In similar way I calculated the weight in every attempt and keep repeating the same till I got required vibration levels. Please refer to below Appendix-2 for detail off each attempt, graphical representation and conclusion.

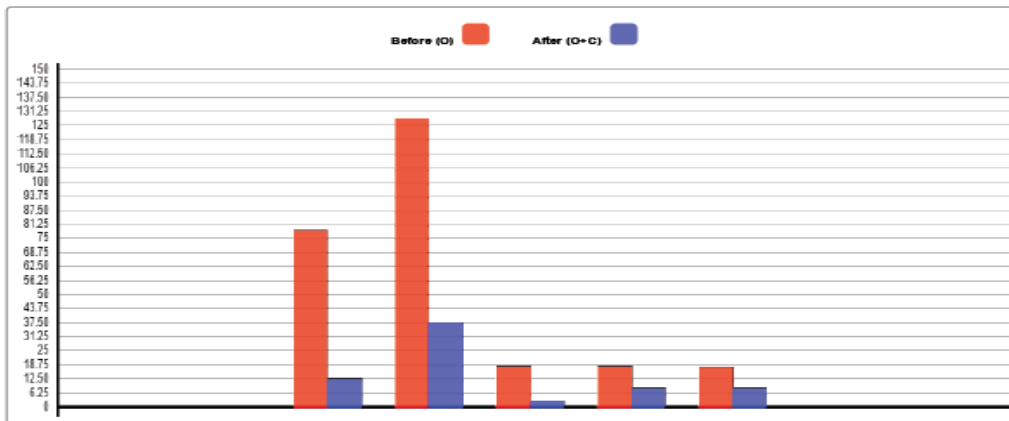
Balancing was performed successfully. Machine was taken into service on base load. Below is a vibration comparison result.

Unit: microns PP	GEN COLLECTOR END		GEN COLLECTOR END SEISMIC SENSOR	GEN COUPLING END SEISMIC SENSOR	
	X	Y	BB12	BB10	BB11
Before	78.5	128	18.33	18.07	17.71
After	12.49	37.37	3	8.26	8.53

- Balancing generator rotor onsite is recommended
- Turbine and generator rotors run out needs to be checked in next opportunity as preventive measure as surface roughness can also lead to vibration spikes/increase.
- Loop-check turbine mid-span probe 39VS-21
