CAREER EPISODE 3

Time duration	
Location	Saudi Arabia
Organization	General Electric (www.gepower.com)
Project	Restoration of GE 7FA-03 Gas Turbine after Compressor Wreck
Position

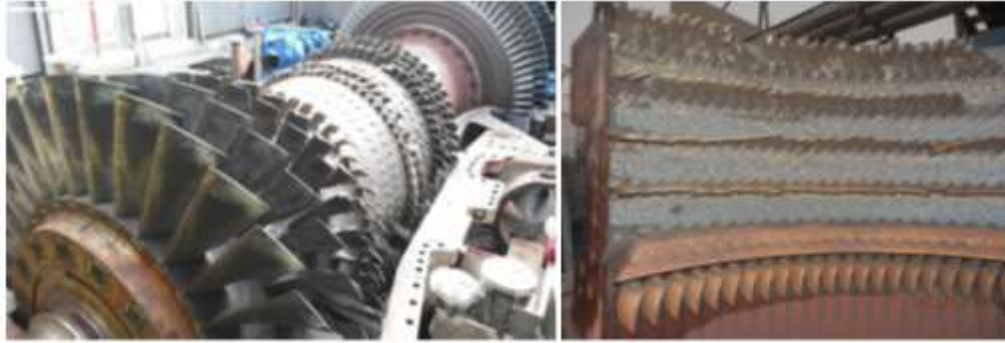
Damaged Assessment: After disassembly I started the project by conducting detailed inspection for making damage assessment of all the compressor rotor & stator vanes. The Mid Compressor Casing (MCC) was also damaged. Pictures of damaged rotor and stator vanes are given below.

In addition to rotor/stator, I performed damaged mapping on MCC as well. Following were my comments after damage assessment and structural analyses of casing:

- Extraction ports flow path – R9 was critical life limiting location and plug repair could not to be applied due to thin casing ligament.
- The gouges will act as stress concentration resulting in crack while in operation over a period.
- Gouges >130 mils on stage 9 would require approximately 10-14 plugs to repair, which was beyond GE fleet experience for a single stage scattered in all the quadrants, could lead to potential casing deformation/operational issues.
- Too many plugs if applied could have a debit in casing life, as the stresses were locally increased with each plug.
- Local Stress increase may lead to Casing out of Roundness beyond re-usable limits or may have operational issues.

On above grounds, I recommended to the customer that complete casing was also required to be replaced in addition to rotor and stator vanes.

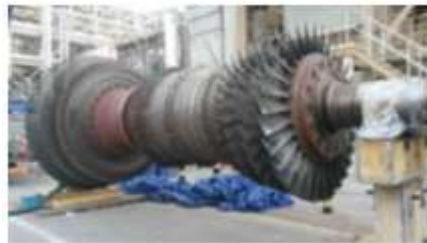
All the upper halves of casings (inlet, CDC, MCC, turbine & exhaust) were removed. After taking opening clearances, rotor was required to be rigged and removed. It was complex and important rigging having rotor weight of more than 50Ton; I designed a lifting plan keeping in consideration the center of gravity. Crane position, boom length, slings and lifting beam were key factors of lifting plan. The lifting plan was approved and rotor was safely removed and placed on rotor stands.

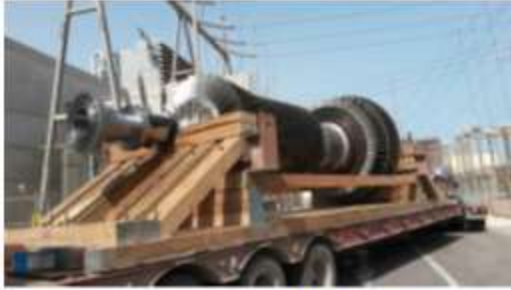
Compressor / Turbine Rotor was replaced with refurbished rotor on back buy deal with damaged rotor, the refurbishment was performed in GE Manufacturing facility Dammam Saudi Arabia (GEMTEC). The rotor had R0 blades with enhanced features of airfoil tuning, laser shock peening and dovetail undercuts.

New rotor reaching at site

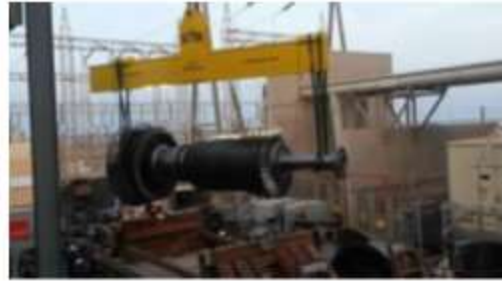
Rigging of new rotor

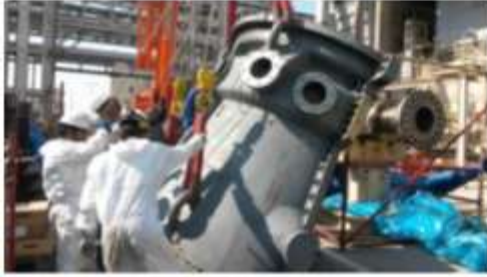
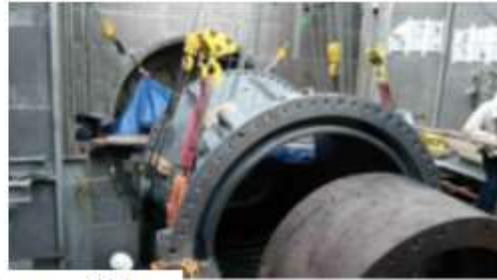
As mentioned above Mid Compressor casing (MCC) suffered heavy dents and damages which were not repairable. MCC was replaced with new one. Prior to installing new MCC, bushings were installed on the dowel holes locations on inlet casing vertical joint (9 places). The purpose was to use the standard size dowel pins after casings alignment.

Installation of Mid Compressor Casing

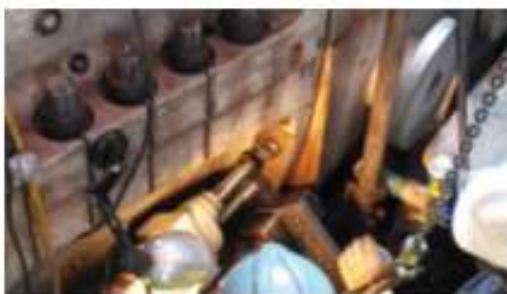
Re-doweling in progress

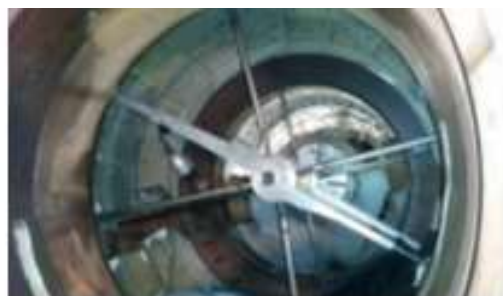
After replacing Mid Compressor Casing internal alignment of all casings was performed. Optical equipment was used for casings alignment. This was unique experience for me. I arranged specialized team of GE Onsite Machining who performed this alignment. Alignment fixtures and targets were set up inside the bearing housing and all casings. After MCC alignment, the alignment of all other casings was checked and found out of limits. All the casings were moved to achieve design specs. After completion of casings alignment bearing-2 offset was also checked and found out of limit which was corrected by moving the bearing housing. After casings alignment, re-doweling was performed for all casings vertical joints.

Alignment of casings

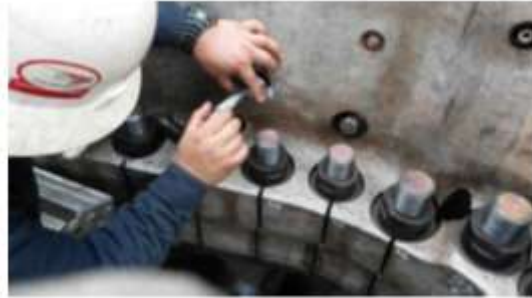
Turbine axial clearances measurement requires the rotor to be set at A-Set Dim with rotor pushed towards active side (exhaust end). While attempting to set the rotor at A-Set Dim by machining of active side thrust shim, it was found varying with temperature. The A-Set Dim was measured in the morning time and active thrust shim thickness was recalculated. Finally A-Set design dimension was achieved and clearances were measured. Compressor and turbine clearances were measured & recorded per new clearance drawing 104T9941 in FMI, all found within specs. Clearances were sent to design team for review and were approved. After installing all the upper half casings, the rotor 6-point check was performed for rotor position and all clearances were found within specs. Inactive thrust shim was machined and Rotor thrust float was set at 10 mils.

6 Point Check in progress
